Inspection Report Minerals Regulatory Program August 9, 2010

Mine Name: Daggett County Clay Pit	Permit Number: S/009/0004
Operator Name: Daggett County	Inspection Date: June 16, 2010
Inspector(s): L Heppler	Time: 9:00 am
Other Participants: none	Mine Status: Ina

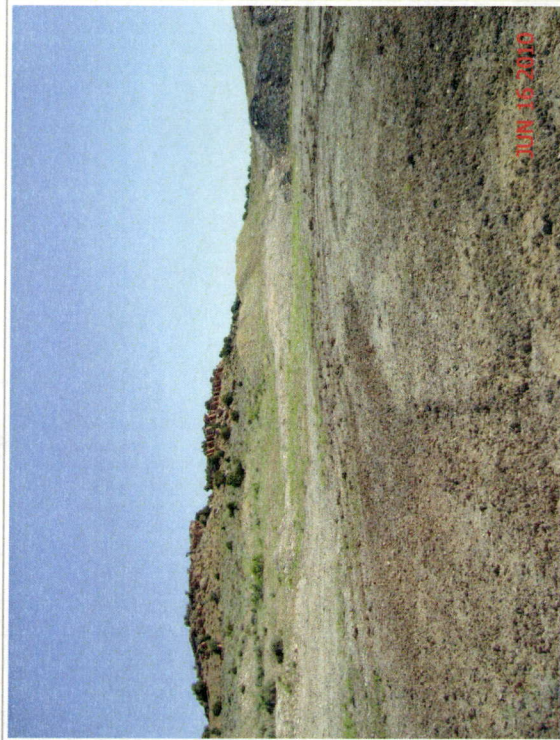
Working pit – Note Topsoil stockpile

Conclusions and Recommendations: There is no bond posted for these sites. Operator should either bond for the total disturbance on the ground or reclaim the areas that are mined out and bond for one working face at a time. It is the recommendation of the Division to interm seed (Crested Wheatgrass) the working faces, top soil stockpile and adjacent areas to help eliminate the opportunity for weeds to dominate the site and spread to other adjacent areas. OGM to continue annual inspections and monitor the site when in the area.

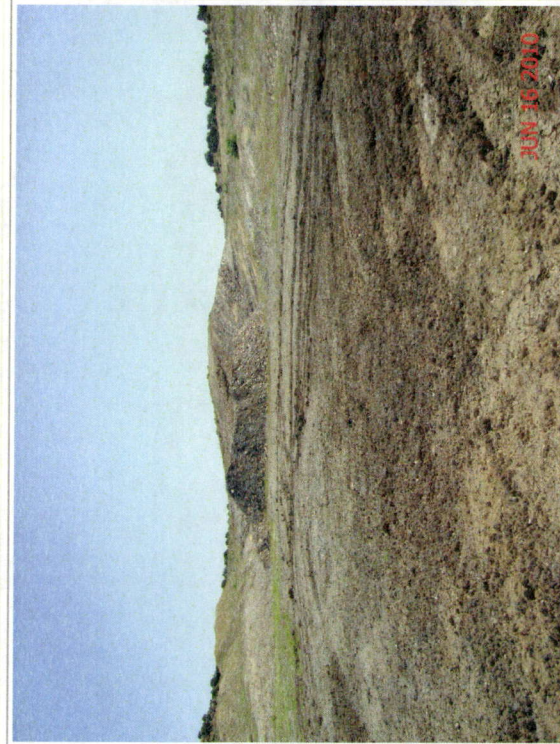
Working pit – Note Topsoil stockpile
